MAINTENANCE PROBLEMS IN THE CASE OF HISTORICAL BRIDGES IN BIALSKI POWIAT IN EASTERN POLAND

KARAŚ Sławomir

KOWIESKA Katarzyna

Lublin University of Technology, Poland

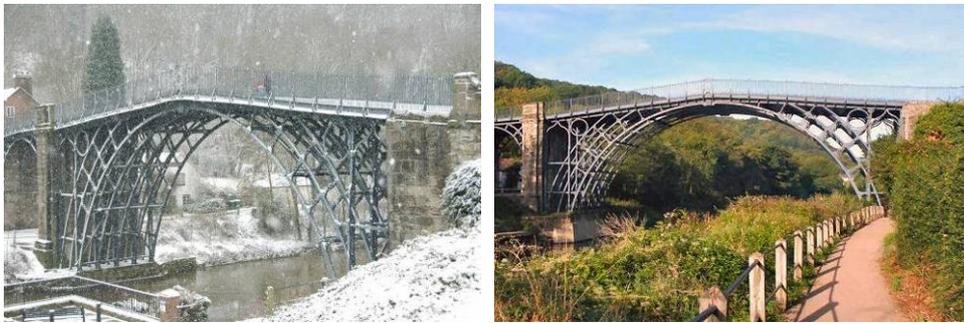
Fig. 1-2. Iron Bridge at Coalbrookdale, England (by the courtesy of Ironbridge Gorge Museum Trust)

The strengthened and renewed structures are monuments of the Industrial Revolution which had place here in XVIII century.

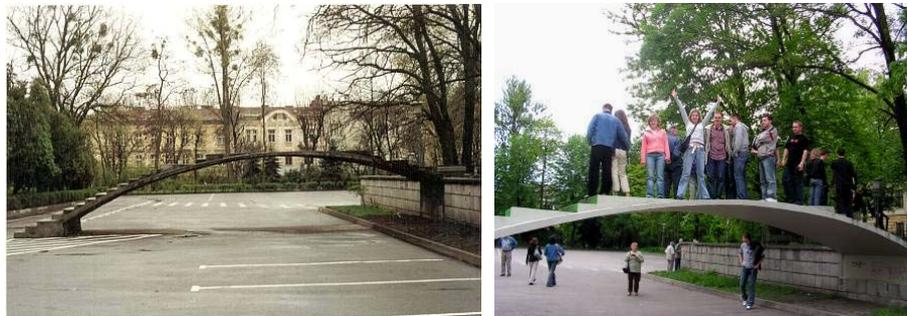
As a second example, the Thullie's foot bridge in Lvov can be recalled. The small plate-arc, erected in the earl period of reinforced concrete age, is now renewed and decorates the park area surrounding Lvov Polytechnic Main Building. This bridge has a deep meaning, being a common engineering monument. It is a hinge which connects Polish and Ukrainians bridge constructors.

Fig. 3-4. The Thullie's foot bridge in Lvov, Ukraine

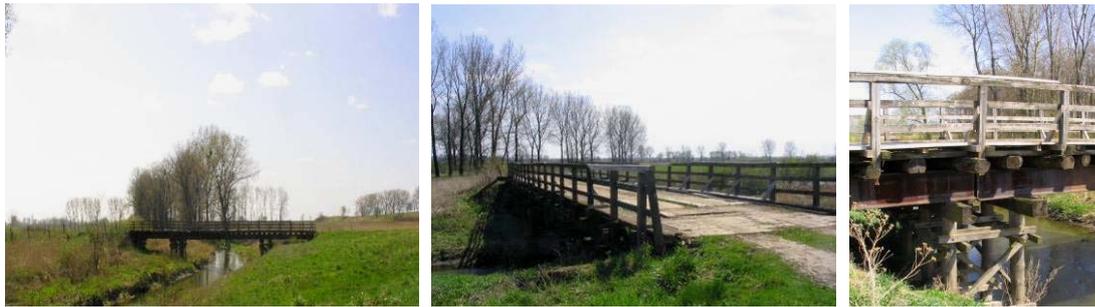
Fig. 5-7. One of the lasts wooden bridges, Werbkowice, Poland

These positive examples cannot bring the full satisfaction. Many historically worth bridges are still waiting for renovation. Probably a whole class of wooden bridges sunk completely from our contemporary landscapes and only old photos remind us about them.

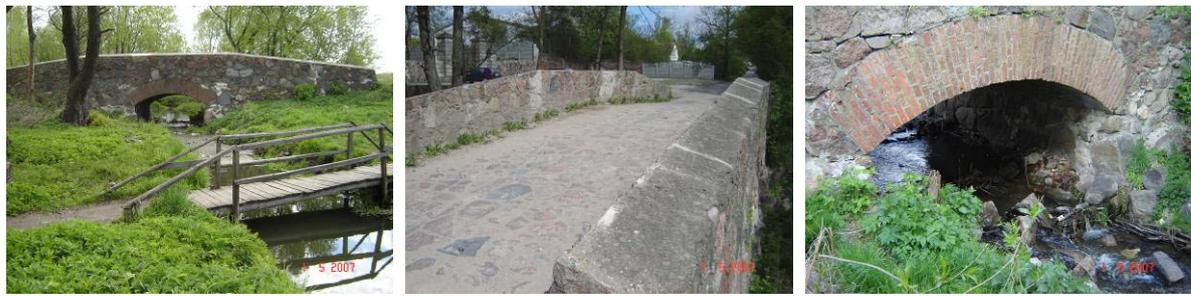
Fig. 9-11. XIX's c. stone pony type bridge over Czyżówka River in Konstantinów village

The used glacial stone material bounded by cement mortar guarantees the bridge serviceability till today and even the pavement has not been changed, Fig. 9-11. The line of arc is underlined by added red brick elevation. Different epoch i.e. the period of industrial revolution gave the steel bridge in Roskosz near Biała Podlaska. Previously it was a railway bridge with the span 24 m and breadth 7,5 m for narrow gauge railway, erected by Germans in 1916-1917 as a *feldbahn* and was in use till 1971 [2]. The bridge was rebuilt into pedestrian one, but this thoughtless works made that probably nobody could be proud of the final effect. The lacks of any conservation and maintenance works are observed in the Fig. 12-14.

The first in the survey is the arc stone bridge in Konstanyńów. The massive structure emphasizes its role in the village landscape and supports the feeling of its safety construction. Indeed the technical condition of this object is almost excellent.

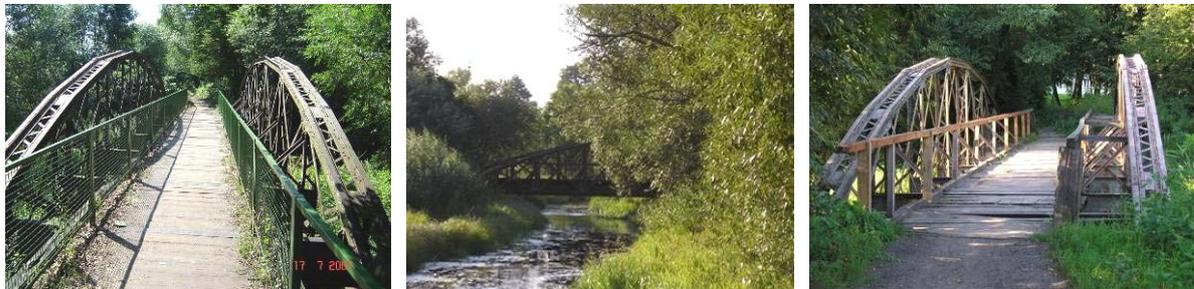
Fig. 12-14. The previously railway bridge truss girders, now used for pedestrian bridge in Roskosz

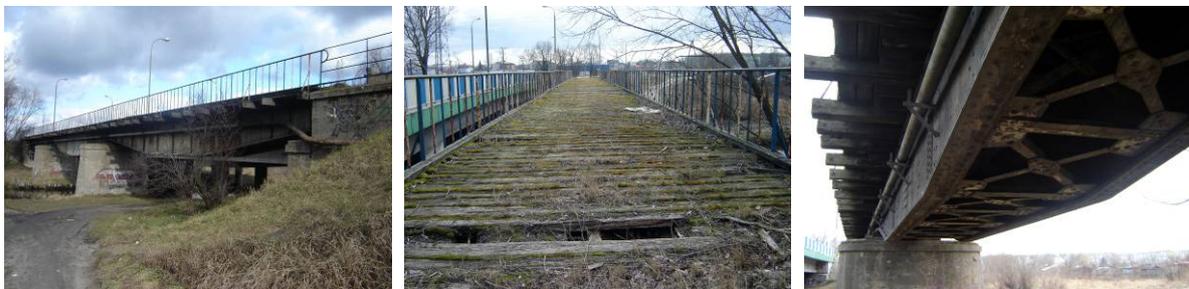
Fig. 15-17. Steel railway bridge in Biała Podlaska over the Krzna River

The steel bridge which has been lying on the same railway tract is in Biała Podlaska. The solid structure and good standard of constructional works made that the bridge, after some conservational works, would be ready to carry the next train.

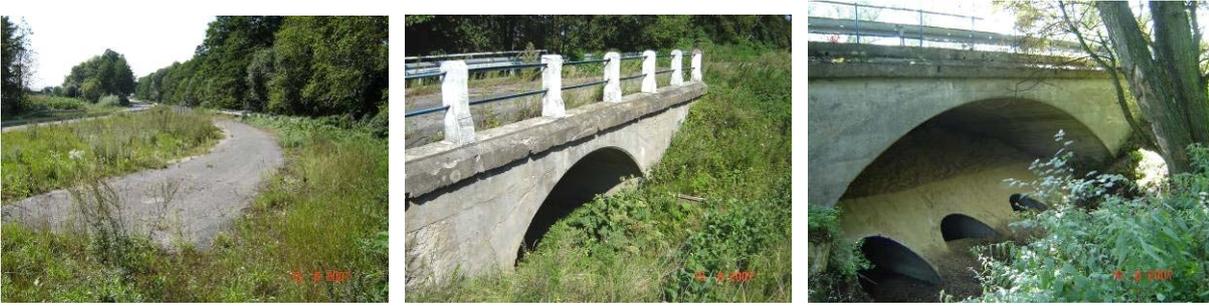
In the village Werchliś on the 698 Road Siedlce – Terespol there are two bridges made of reinforced concrete. They were erected before the Second World War. In 2003 the road was rebuilt and as a result of this the bridges are now excluded from traffic use. In those cases we can also observe the changes in the water system. The previous rivers water volume has been considerably reduced due to numerous meliorations in recent 30 years, Fig. 18-20.

Fig. 18-20. The 70 years old reinforced concrete bridges in Werchliś

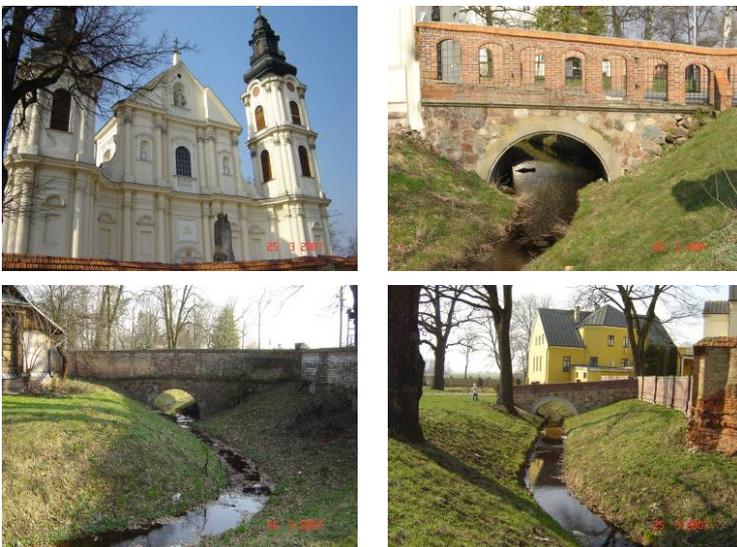
Fig. 23-26. The church and the bridges in its neighbourhood

The road runs close to monastery and is crossing several rivulets. During the time of monastery prosperity all roads led to the church hill, crossing water springs by stone bridges. Most of them are now renovated and nowadays play the same role for the faithful as it was in the past.

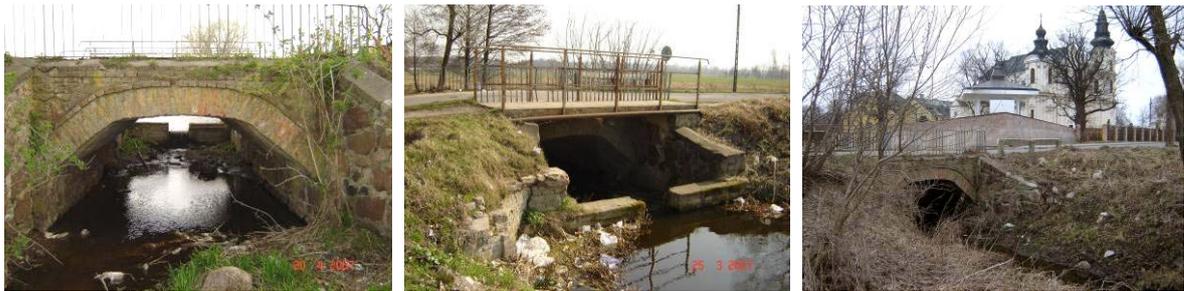
The current view of the culvert and the longitudinal cross-section of designing variant are shown in the Fig. 27-29. We assume the culvert parameters according to typical element known as ViaCon A17, [3].

Fig. 27-29. The historical culvert in Leśna Podlaska

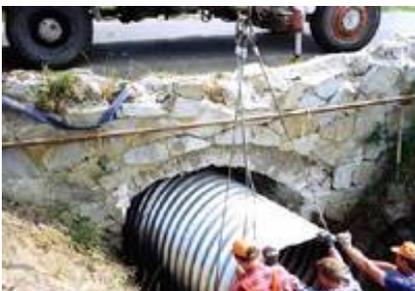
Fig. 37

Usually the corrugated culverts are used in rather different manner, see Fig. 37. The pipe or shell is slid into the existing bridge or culvert opening. Comparing this technology to herein discussed one, it is easier and cheaper, but in this case could not be effective.
